RE: Excavation Water Management – Former Nuodex Corporation Facility Fords, New Jersey

Figure – Lead Berm Excavation Delineation and Sample Location

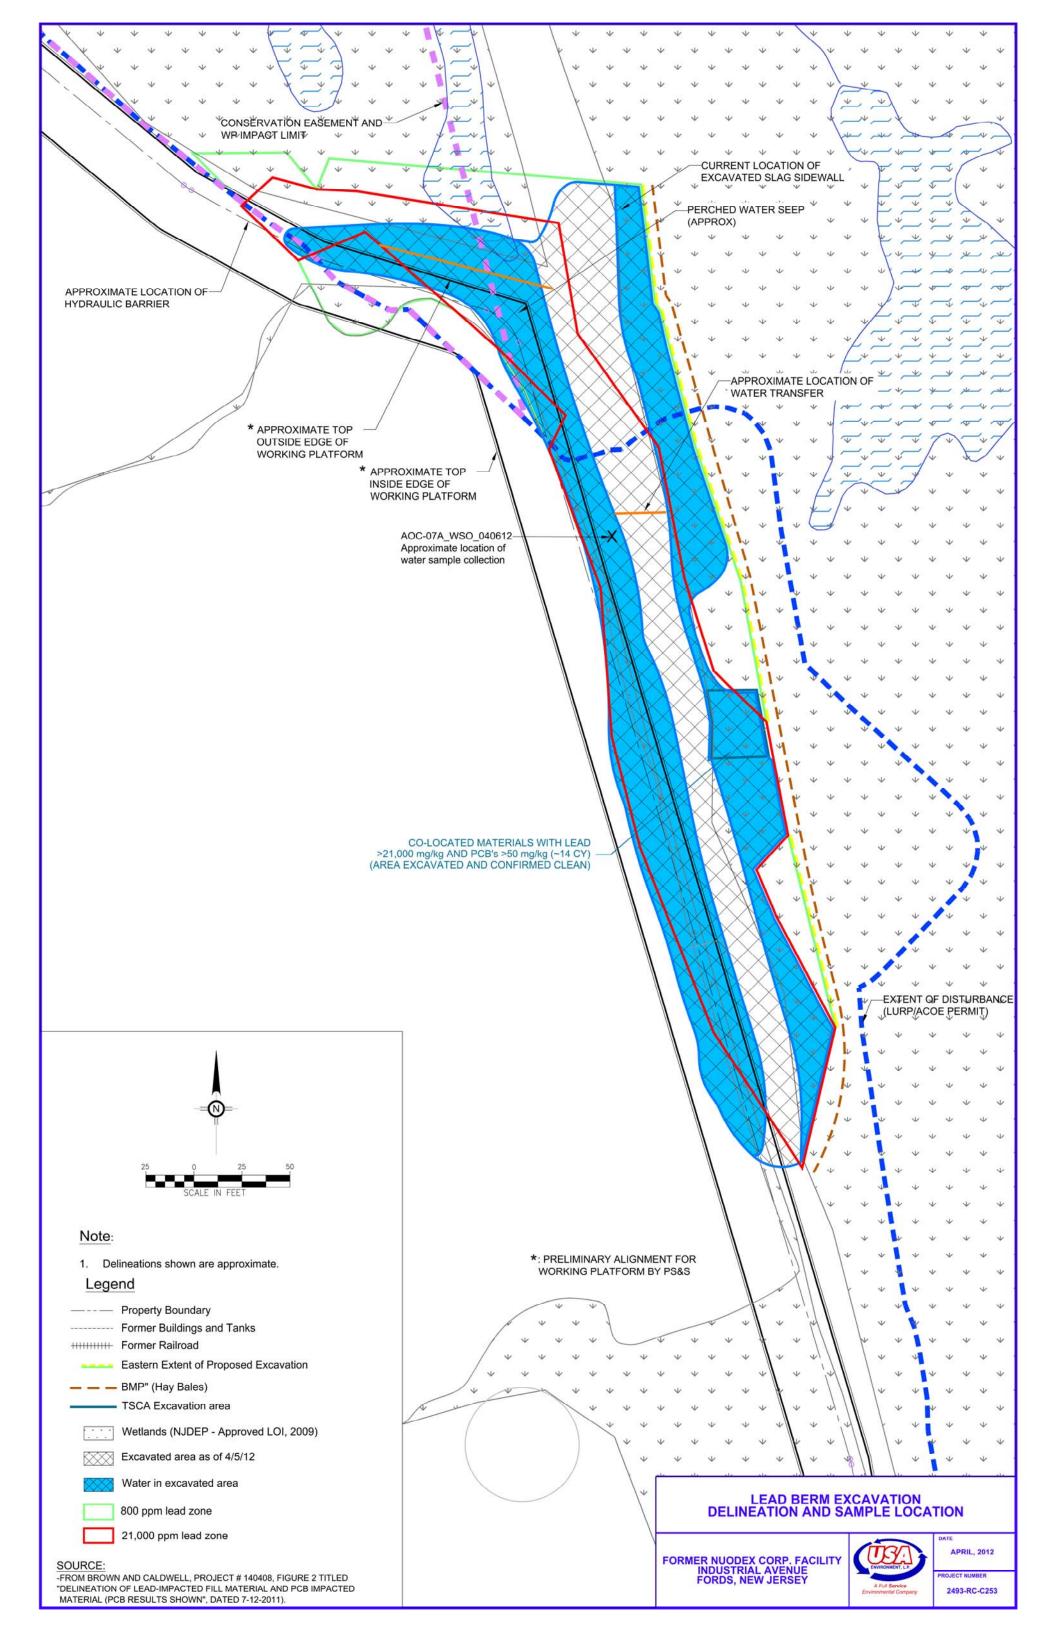
The lead impacted soil excavation area is located in a portion of the site that is bounded on the North by wooded wetlands, to the East and south by wetlands, and to the West by a former pond (Hartman's Pond) which has been filled with coarse aggregate as part of the remedial activities. The lead impacted soil formerly served as a berm that contained Hartman's Pond from the lower-lying inundated wetlands to the North and East. The lead and PCB impacted areas extend laterally from the top of the former berm into the wetlands to the North and East as shown on the attached figure.

The excavation in the higher portion of the lead-impacted area became inundated with water. Excavation within the lower lying wetlands to the East was also conducted in accordance with a phased excavation approach. The attached sketch outlines the excavation areas that are inundated by water.

As detailed during our April 6, 2012 conversation, water from the western portion of the excavation was allowed to drain to the eastern portion of the excavation. The location of the water transfer is reflected on the attached figure. Water flowing into the eastern portion of the excavation was within the alignment of the SESC provisions (i.e., haybales).

Pursuant to our discussion, a sample was collected on April 6, 2012 from the standing water located within the western portion of the excavation (see attached figure). PCB data from this sample are presented below.
